# Oxygen Related Accidents/ Incidents in Gas Industry – Learnings

Haris Farooqi

Director, Plant Technical Solutions – Asia, **Air Products**

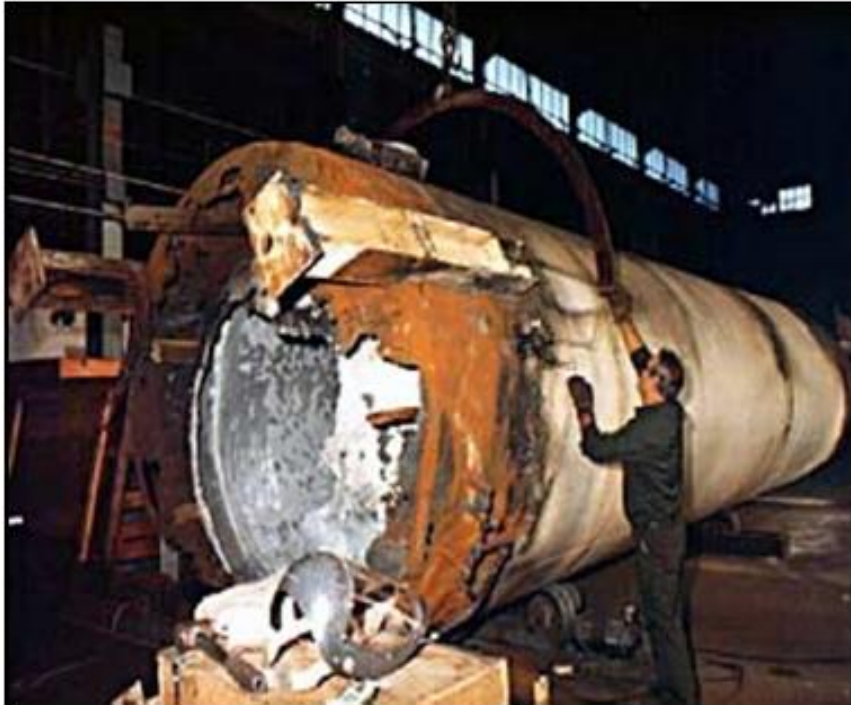
## LOX Tank Fire - 1981

- Resulted in **several fatalities**
- Vertical LOX storage tank ignited and burned through the bottom and top
- Tank had an aluminum inner vessel and a carbon steel outer vessel.
- Likely cause: **friction** from an aluminum internal tube (dip tube) **rubbing** against an aluminum support caused the ignition.
- Company has **prohibited** the **use** of **aluminum** inner vessels in **LOX tanks** since this incident.

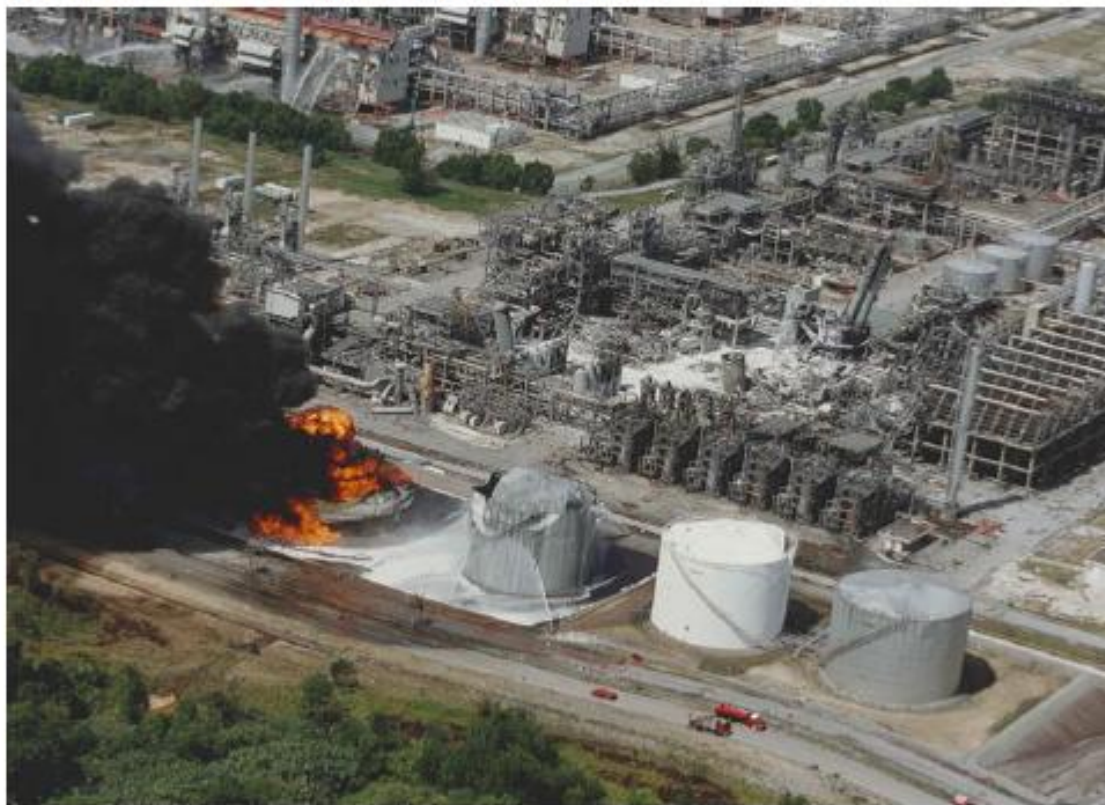
## ASU Plant Explosion - 1997

- ASU reboiler explosion led to fire
- **Hydrocarbon Accumulation**  
>> Combustion >>  
Aluminum  
burning/explosion

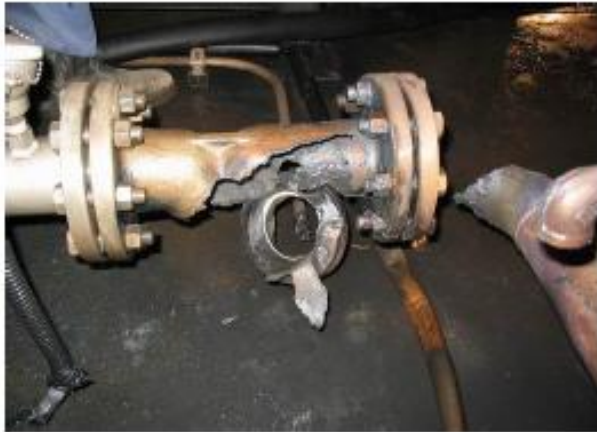
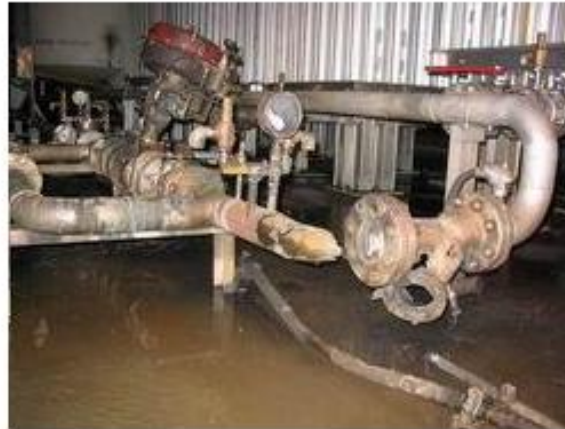
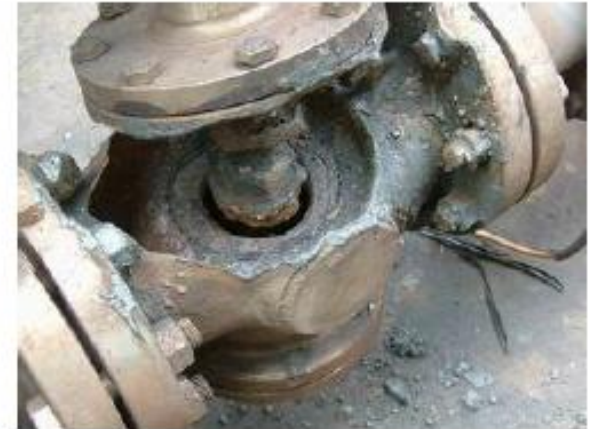
## Oxygen Energy Release

- Oxygen Energy released during **commissioning** of pressure control manifold.
- Eight people severely injured (burns) - **one** subsequently **died**.
- Highlights need for oxygen piping **design expertise**, **oxygen cleanliness**, adequate Hazard Review and Operational Readiness Inspection and safety precautions during **commissioning**.

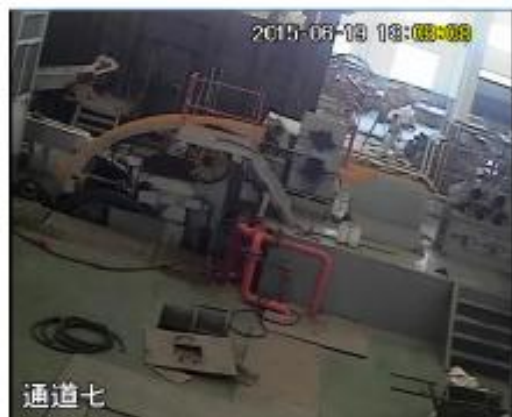
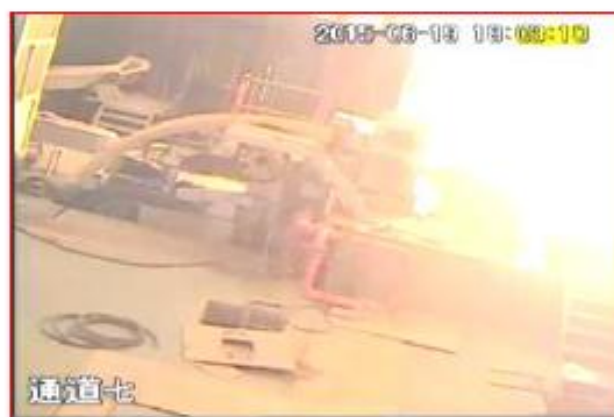
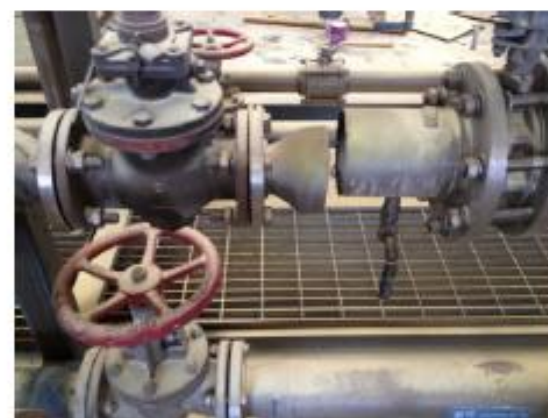
## Oxygen Fire – Oxy-Combustion Skid

- Flame erupted from an oxy-combustion skid being commissioned at customer location
- Multiple burn injuries to personnel who were present there to get trained
- Likely ignited by rust/particles in a strongly oxidized hydrocarbon mixture (HC solvent introduced by customer for pipe cleaning) carried from upstream pipe
- Flame released out of poor quality weld on the oxygen piping skid.

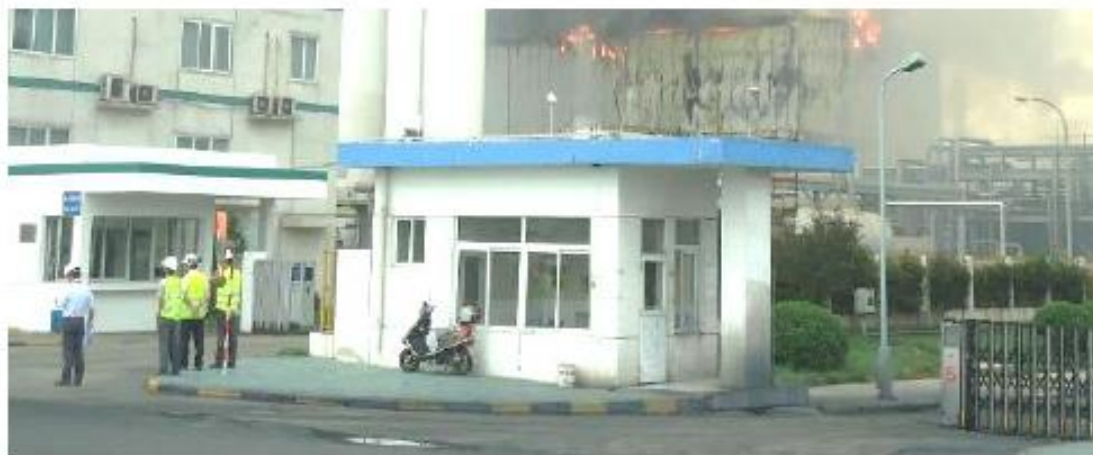
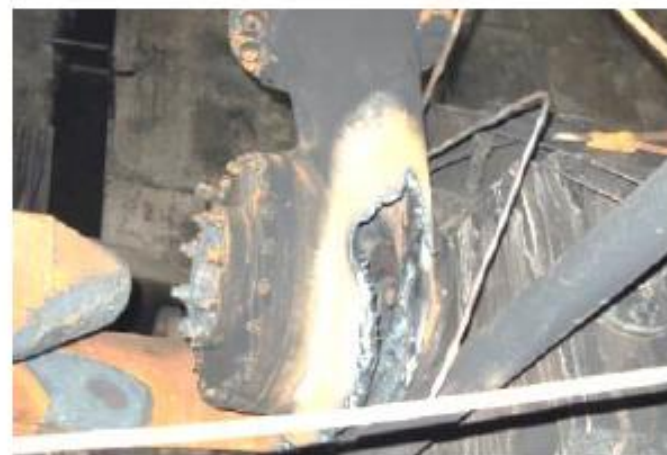
## N2 Compressor Fire (O2 Migrated via cross tie-in)

- 2<sup>nd</sup> GAN compressor **was added for reliability of supply (locally)** with cross tie-in so that both ASU1 and ASU2 can feed into either of the GAN compressors
- On day of incident, ASU 1 tripped and was being restarted. N2 with high O2 (during ASU restart) was fed to the compressor (**manual valve in cross-tie not fully closed**) – led to fire in compressor

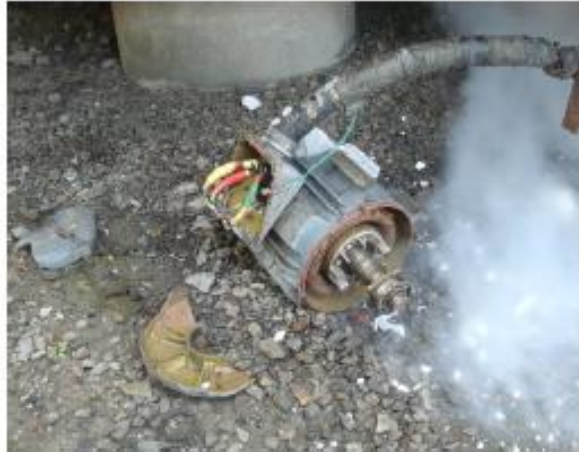
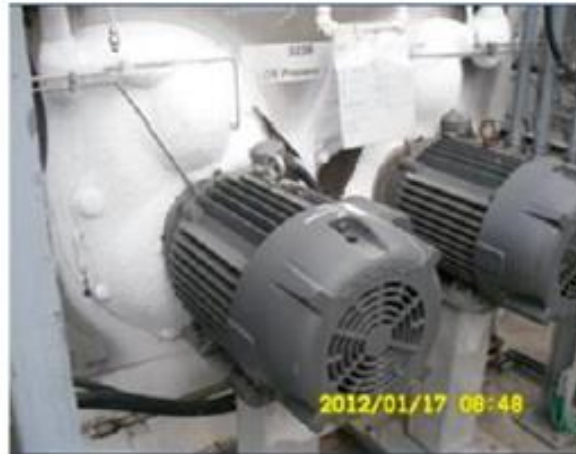
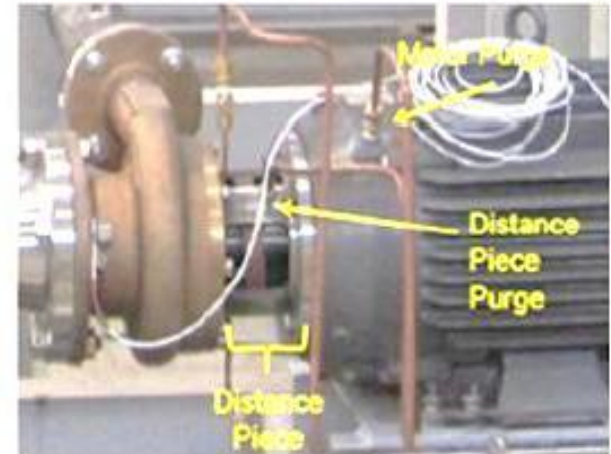
## LOX Loading Pump Motor Energy Release

- Oxygen: Pump seal leak, O<sub>2</sub> migrated from pump to motor through the tunnel created by ice ball over the distance piece
- Combustible Material: Electric motor components are not O<sub>2</sub> compatible
- Ignition Source: Not exactly known. Probably by heat generated from normal motor friction.

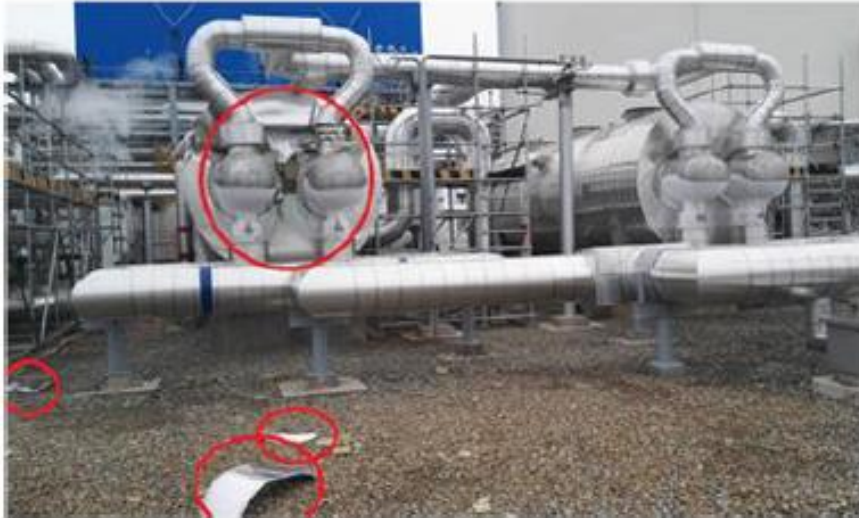
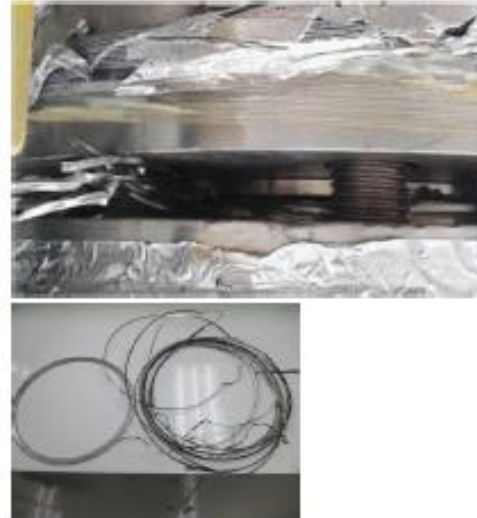
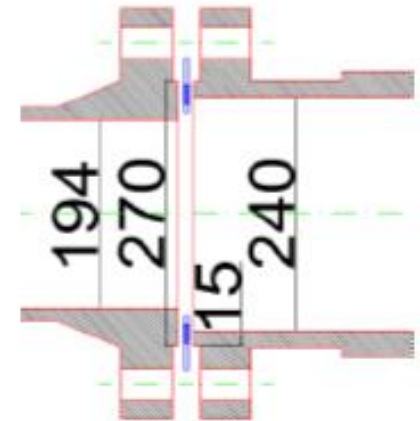
## GOX Gasket Failure

- The mismatch of flange seal surfaces resulted from **wrongly designed and manufactured outlet flange**, with wrong ID dimension. Error made by vendor designer.
- **Error not caught during drawing review and approval.**
- **Wrong gasket installed** (150# was installed instead of 600#)

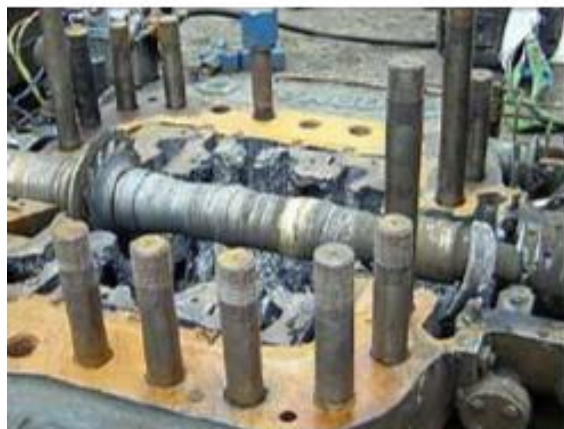
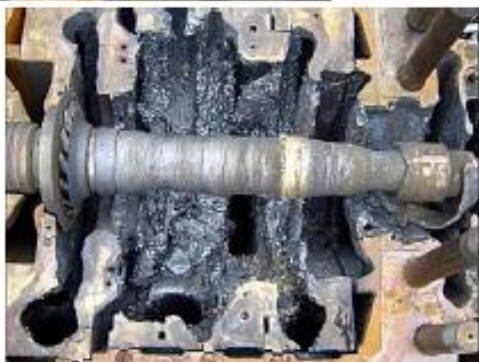
## GOX Compressor Fire - 2002

- Fire initiated in compressor; molten slag and metal flowed to the piping, ignited it and caused the breach.
- The fire lasted 5 seconds.
- As a safety precaution all oxidizer compressors are barricaded. Barricade contained the fire preventing injury.
- Likely the fire was initiated by frictional rub; rub likely caused by fatigue failure of an internal part (impellor cover or blade)
- Rubs possible in compressors; cause friction ... ignition ... combustion. Practice is to barricade oxidizer compressors and to allow personnel access to the compressor only during outages.

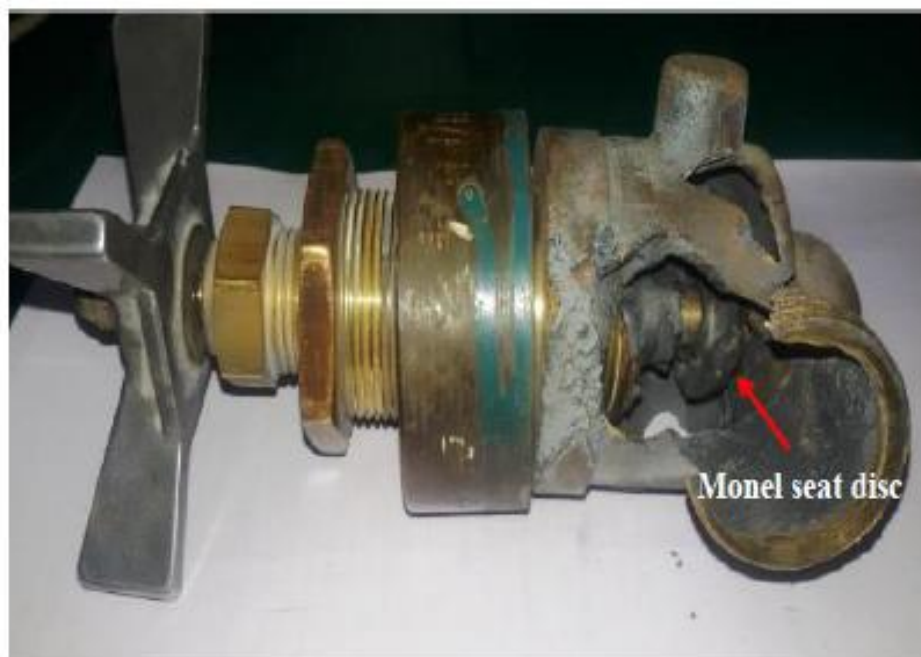
## Energy Release – O2 Cylinder Fill Panel Valve

- Fire occurred at the back of inlet valve located on manifold panel which was being opened to change over.
- Maintenance (including degreasing) was done on valve two days prior to incident to fix leak in the valve.
- O2 Cleaning procedure not strictly adhered to during maintenance event.

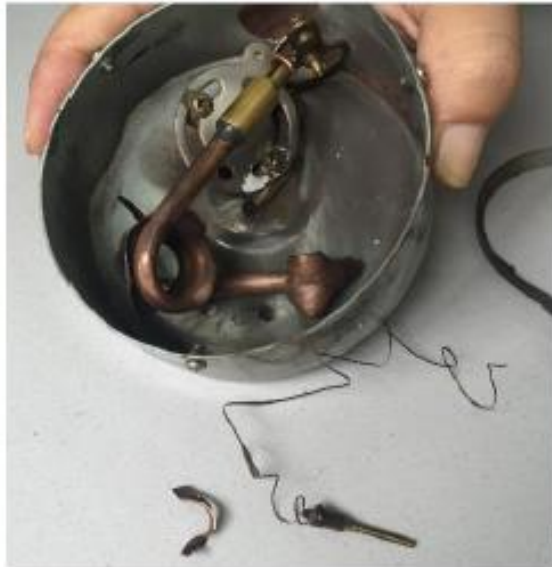
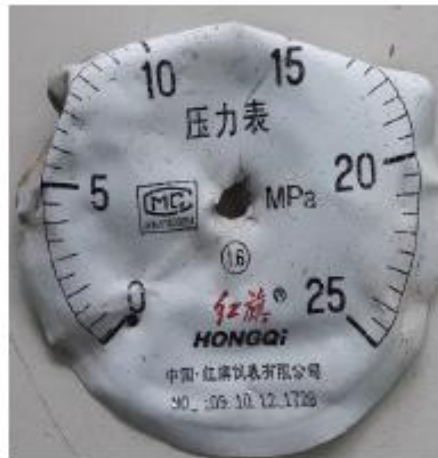
## Pressure Gauge Burst During Cylinder Pressure Check

- Operator was doing pressure check for medical oxygen cylinder.
- Incident happened when operator tightened the screw, and opened cylinder valve slowly.
- The gauge glass shattered injuring the operator on the right side of the chest.
- The gauge that was used was not compatible for oxygen service.

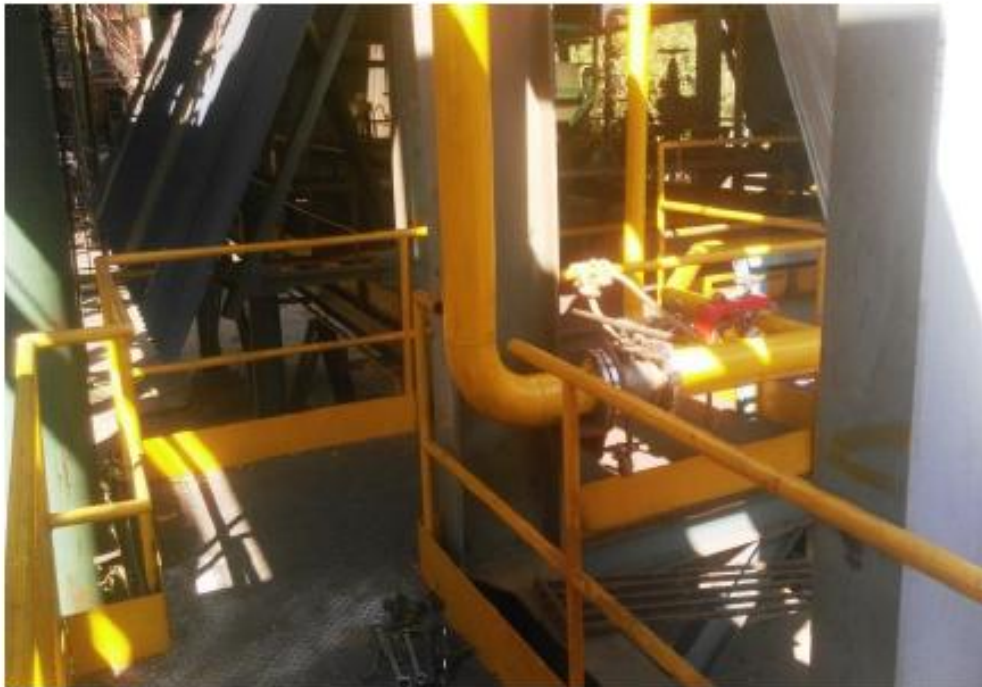
## Oxygen Pipeline Fire at Customer Site During First Fill

- Employee suffered **burn injury** when **O<sub>2</sub>** was **charged** for the **first time** into the pipeline
- fire occurred at the upstream flange of the valve.
- Valve was **not cleaned** for **oxygen service**
- Less than adequate **PPE**
- **No SOP** for charging oxygen for the **first time** in pipeline

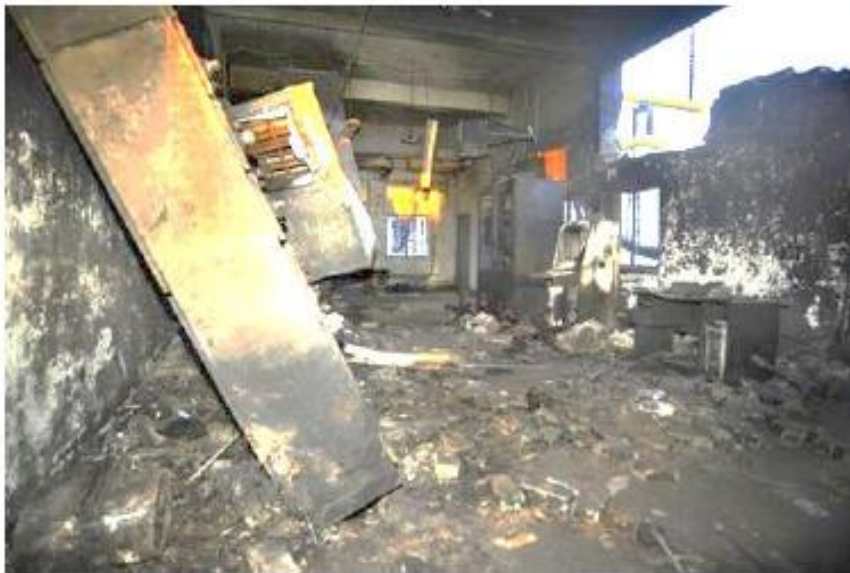
## Major Fire & Explosion At Oxygen Pipeline Pressure Reducing Station

Destroyed Control Room

- Fire and explosion at pressure reducing station on new O<sub>2</sub> supply pipeline during **commissioning**
- Large number of **people** (~50) present at the control room at the time.
- Fire destroyed the control room and **19 people died**.
- Trapped particles in the filter at PRS (after the fire) showed that **particle impingement** on the steel pipeline in the filter area could have occurred that resulted in **ignition**.
- **Design practices** to prevent excess oxygen velocity might not have been properly followed.

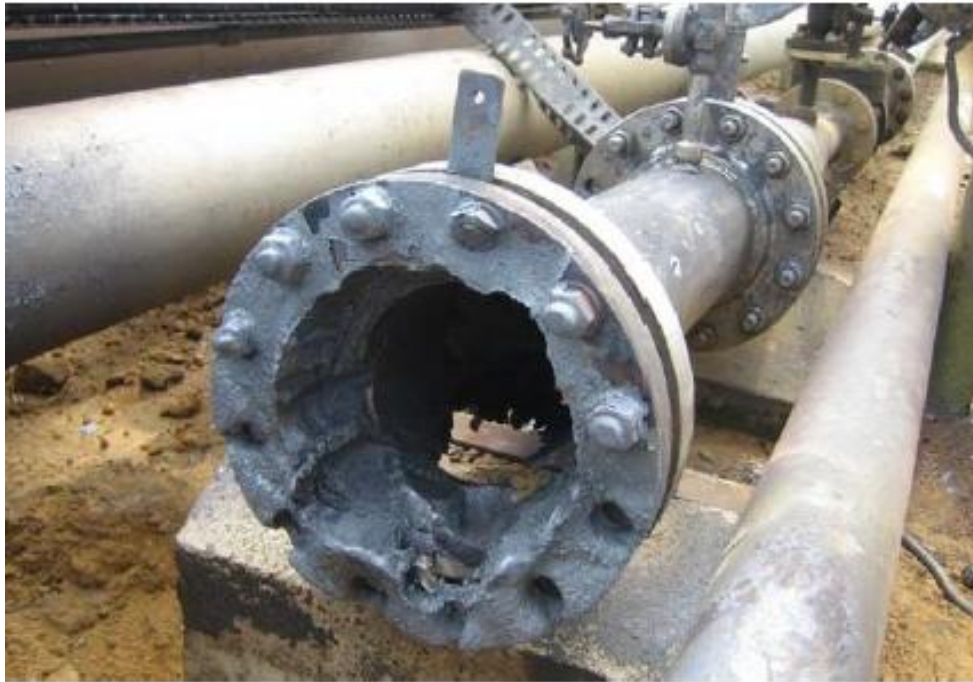
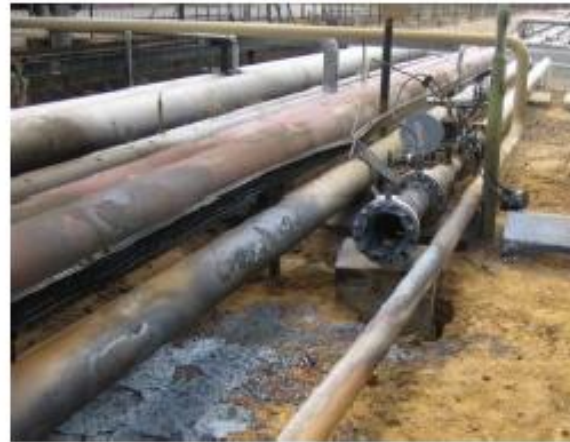
## Oxygen Pipeline Fire At Conical Filter Flange

- 6-inch O<sub>2</sub> line – 3m section “consumed”
- Incident happened after upstream O<sub>2</sub> tripped and was re-started
- Particle impingement/ high O<sub>2</sub> velocity

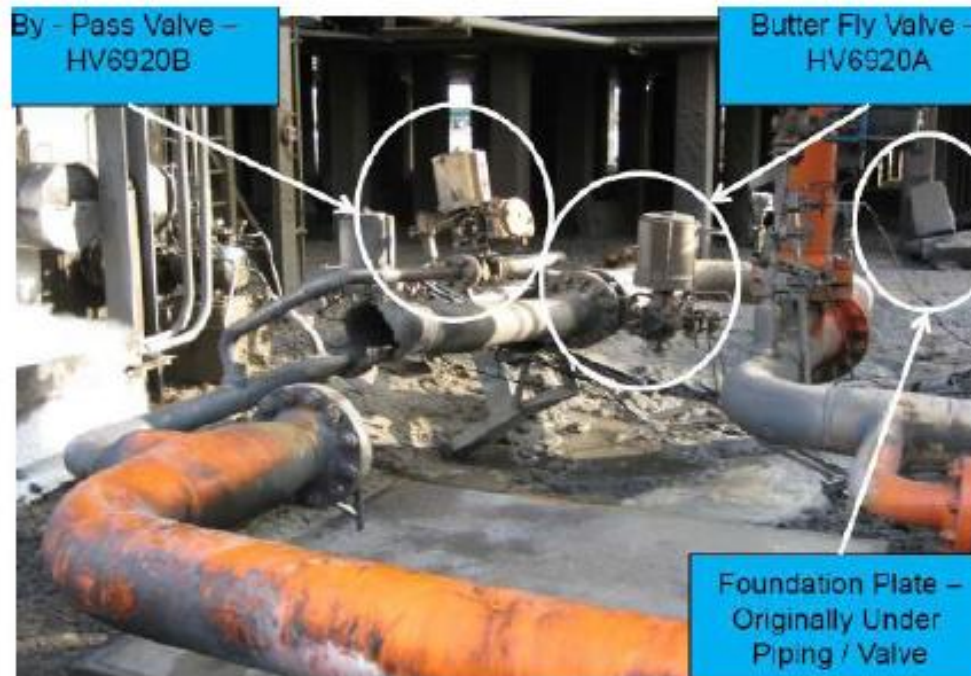
## Oxygen Pipeline Fire - Newly Modified Piping During Commissioning

- Deficiencies in O2 System Design expertise
- Inadequate Management of Change (MOC) approval process
